**Diamond Creek Lot 33**

UPDATED ARBORIST REPORT

William O'Neil  
ISA Certified Arborist WE-6163A  
TREE CARE INCORPORATED

November 16, 2017

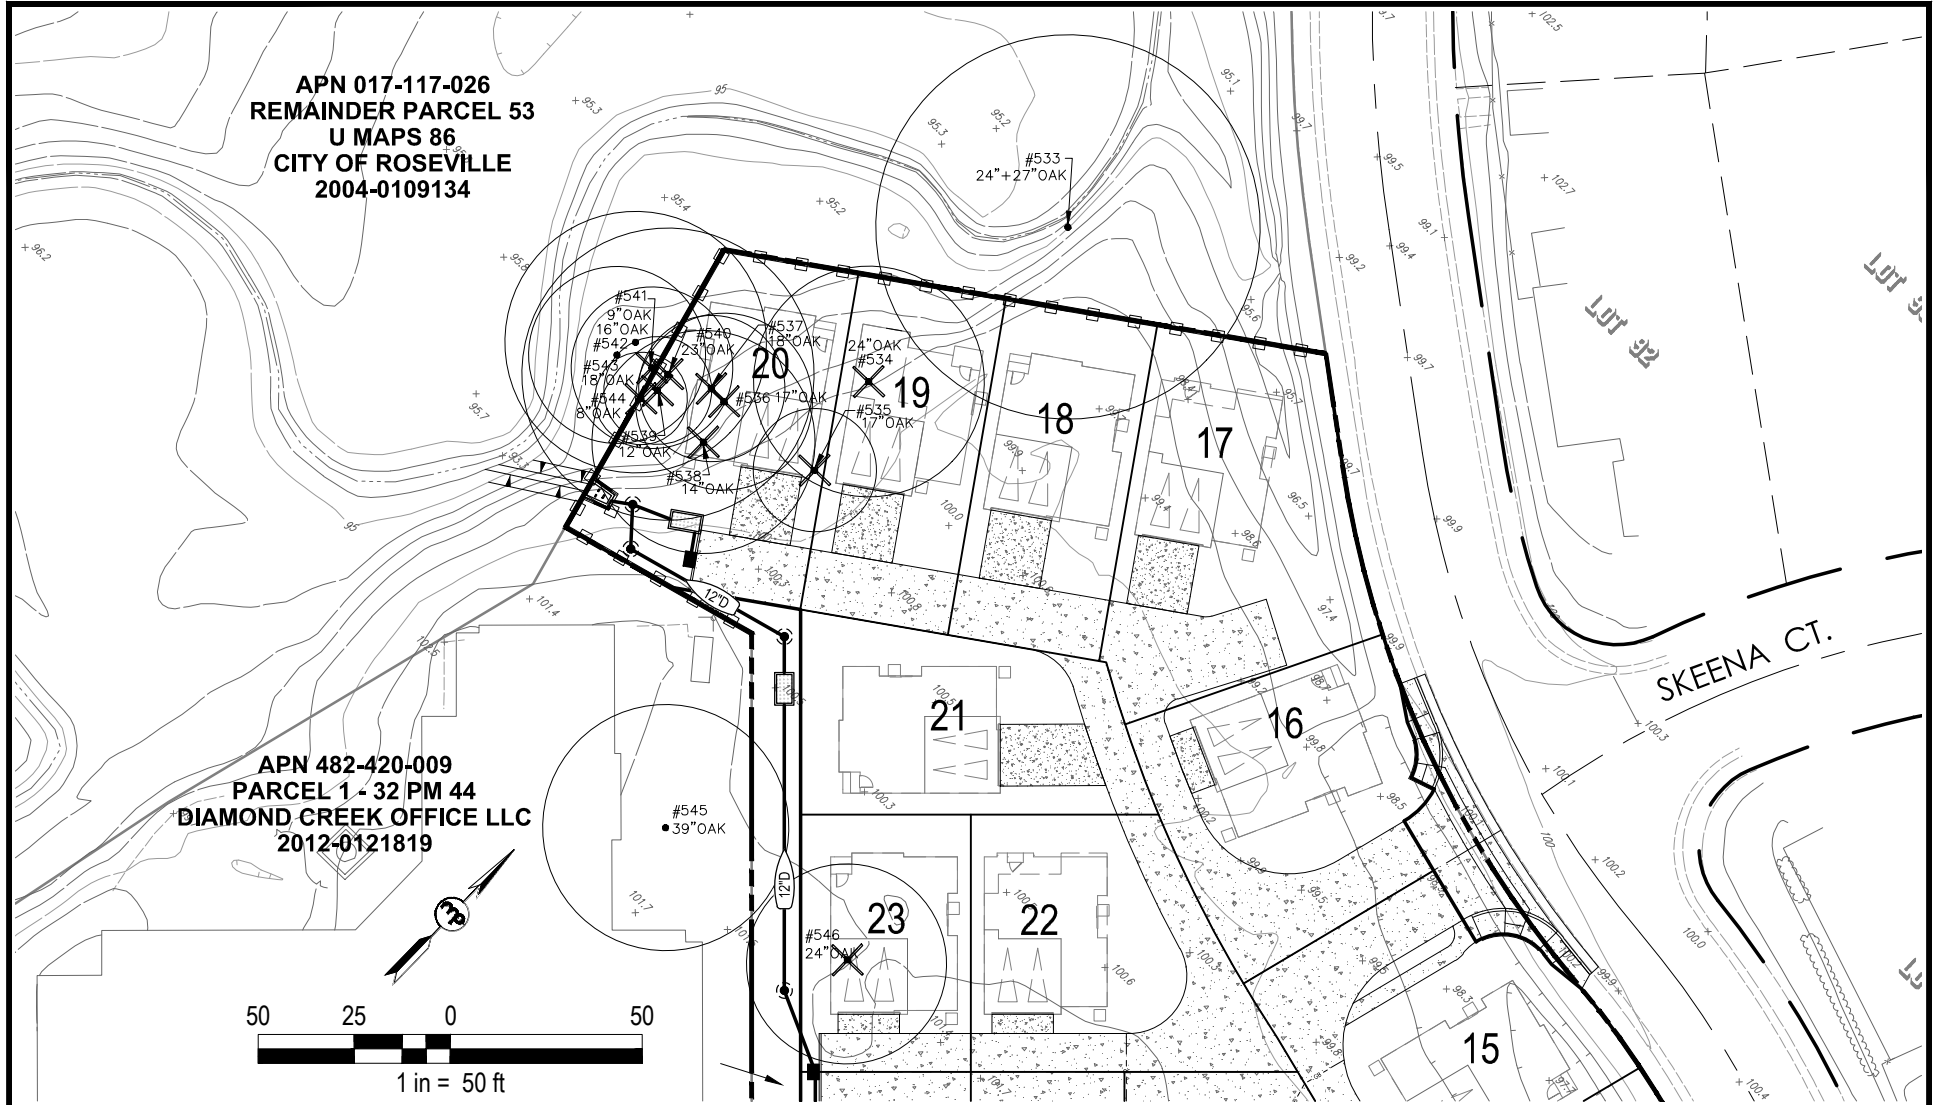
TREE DRIP LINE EXHIBIT FOR:

After reviewing and discussing the proposed construction and grade change plans it is my understanding that the grade will be increased by approximately 4 feet and a concrete wall installed in the dripline of the trees, this will impact a minimum of 50% of the drip lines of tree numbers 536-541. Construction within these root zones combined with stress from recent drought years will most likely cause rapid decline, failure or death of these trees in the near future, even if the plans were changed to construct the wall around these trees.

Tree numbers 542 and 543 are the only trees that would be a possibility of preserving. Tree number 543 is not in good health and will likely die after construction due to the impacts within the root zone. I recommend this tree be removed prior to construction. Tree number 542 is in fair health considering the recent years of drought and can likely be retained if steps are taken to minimize construction impacts within the root zone i.e. install protective fencing around the dripline and avoid any unnecessary disturbance of this area during construction (see enclosed literature).
