Dry Creek Greenway Trail Fluvial Audit

December 2014
Project Number: 13-1041

**DRY CREEK GREENWAY TRAIL FLUVIAL AUDIT
ROSEVILLE, CA
FINAL REPORT**

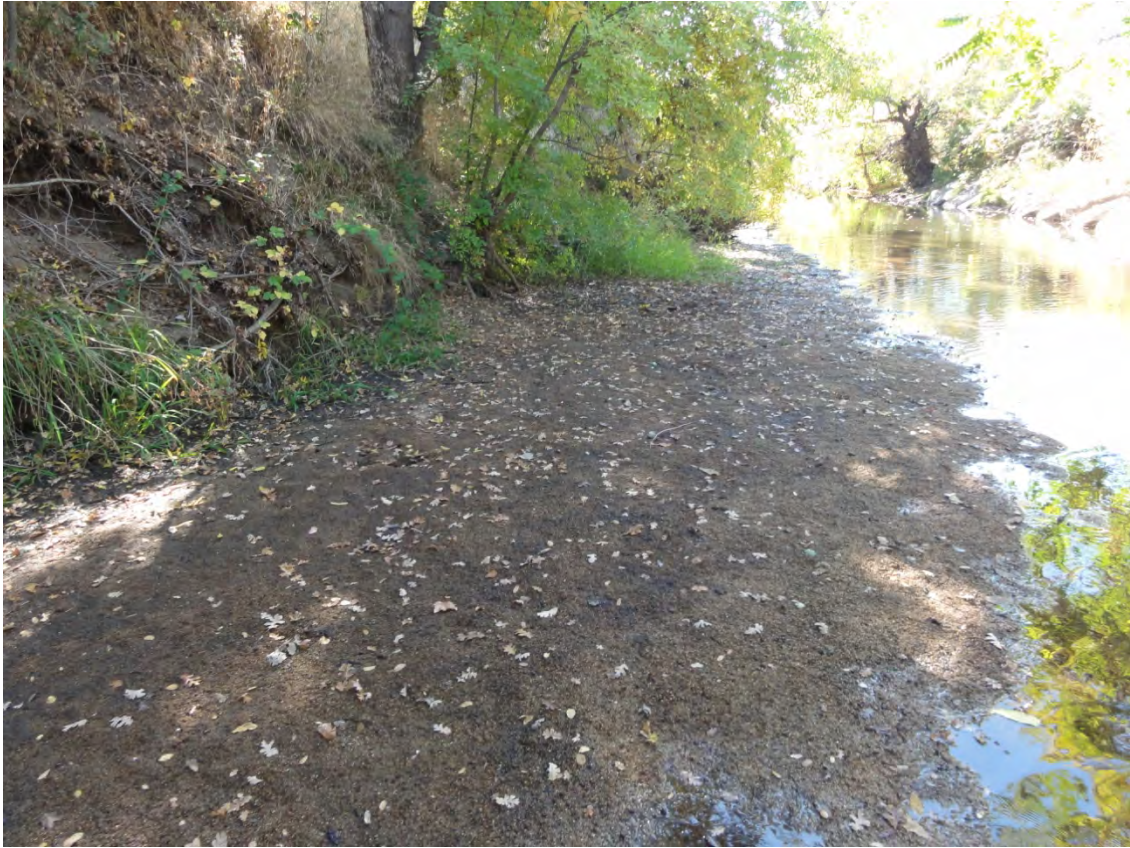
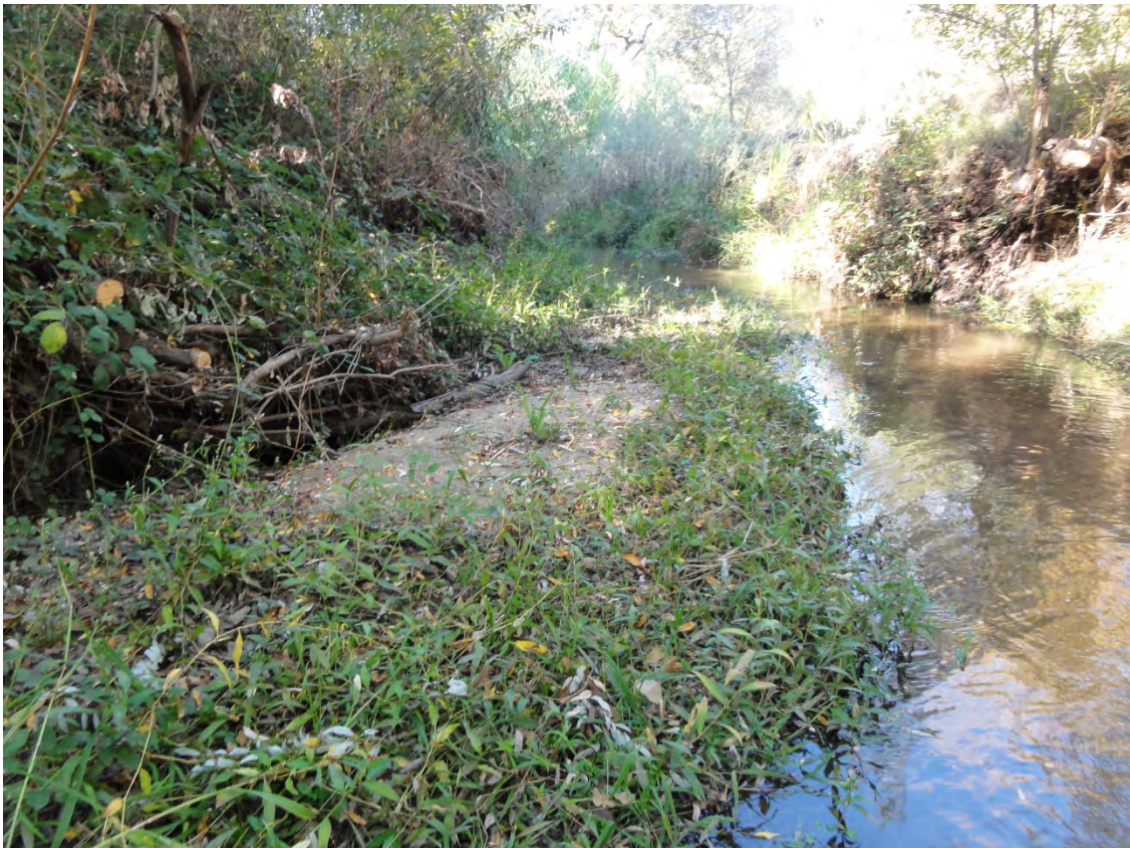
Figure 9

Notes: Un-vegetated bar (top) suggests recent deposition; lightly vegetated bar (bottom)

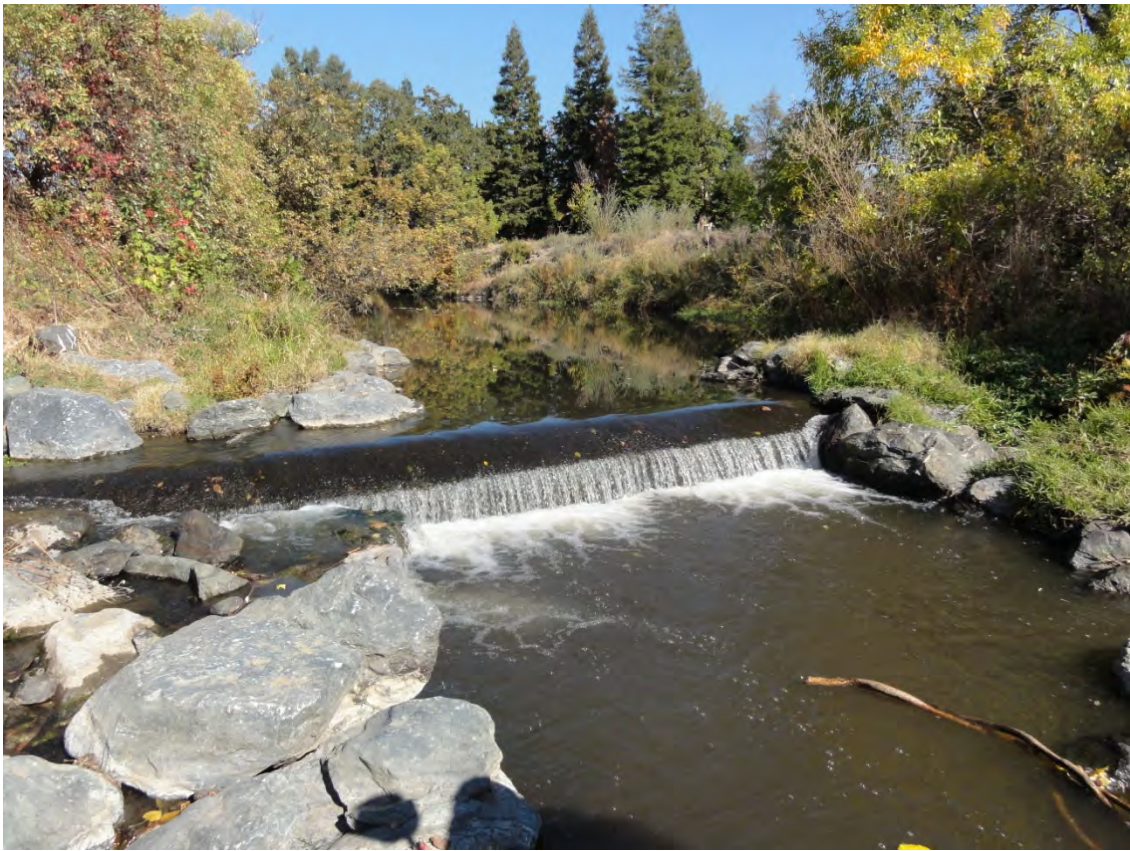
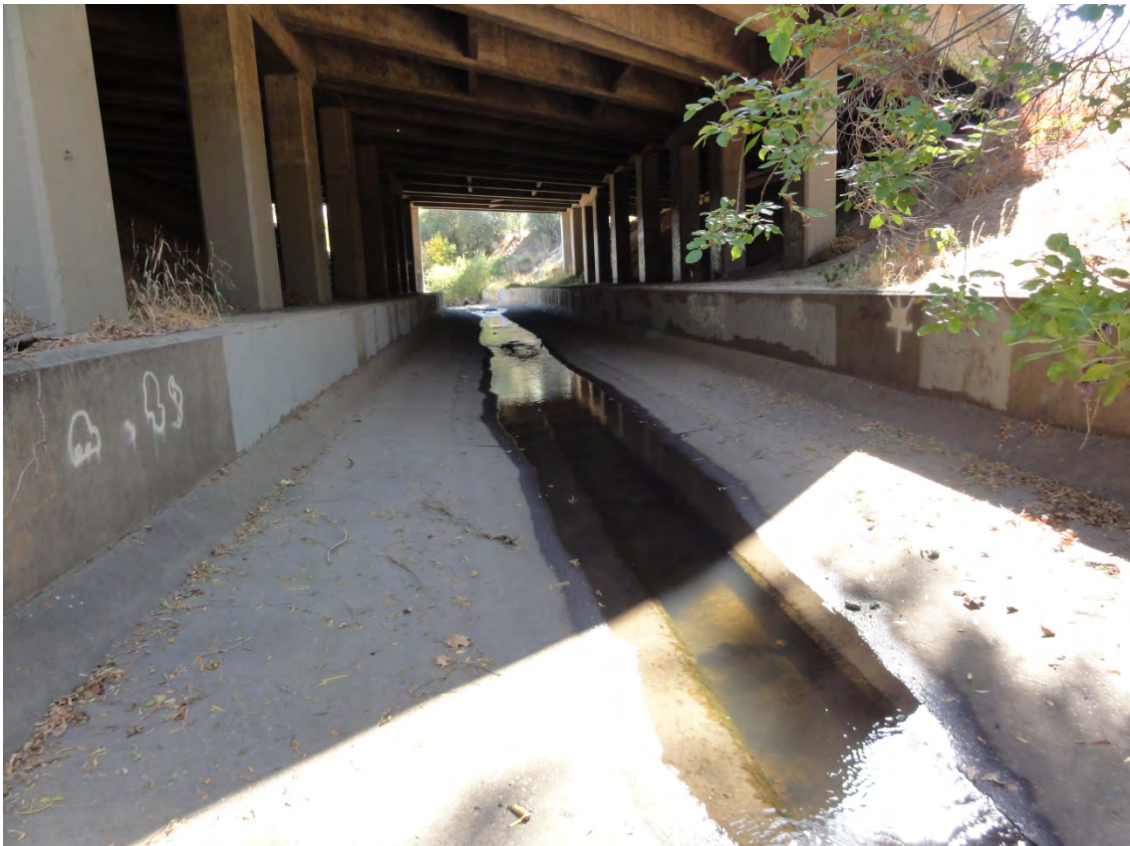
Figure 10

Notes: Concrete-encased sewer line functions as a weir on Dry Creek at confluence with Cirby (top); I-80 culvert on Cirby Creek (bottom)

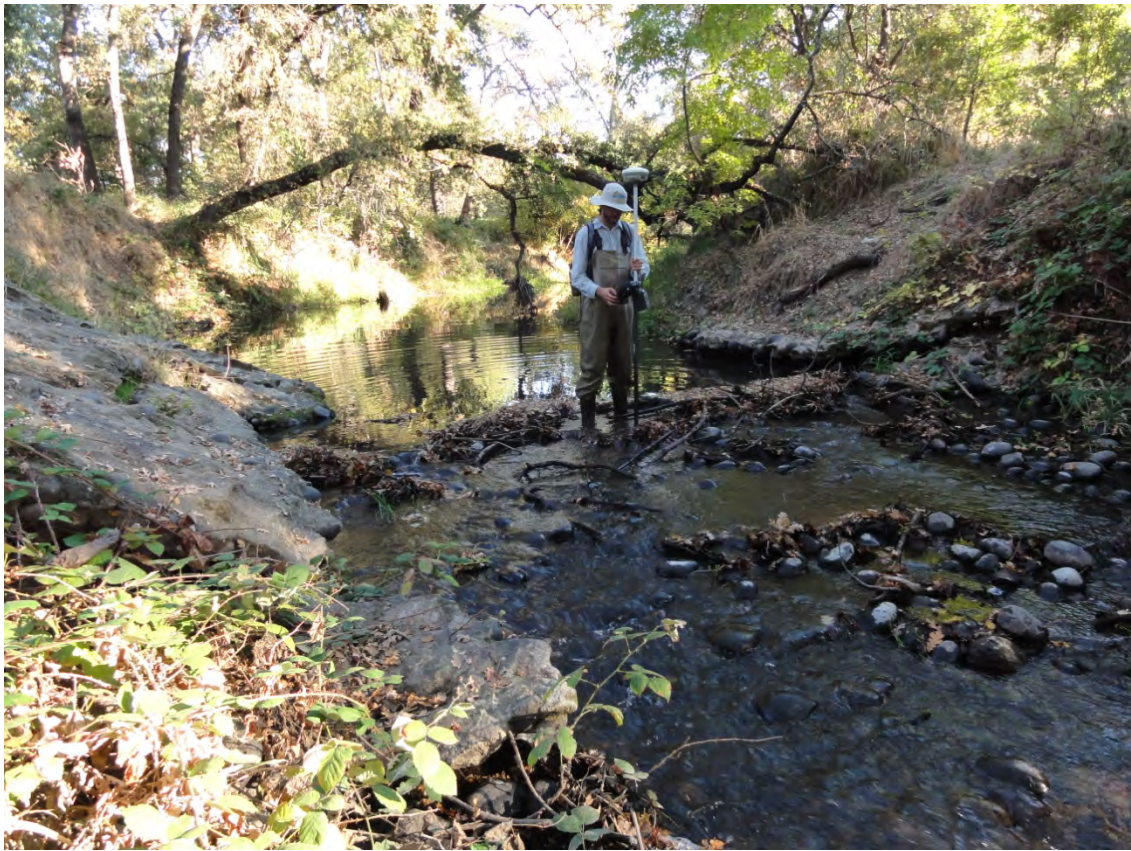
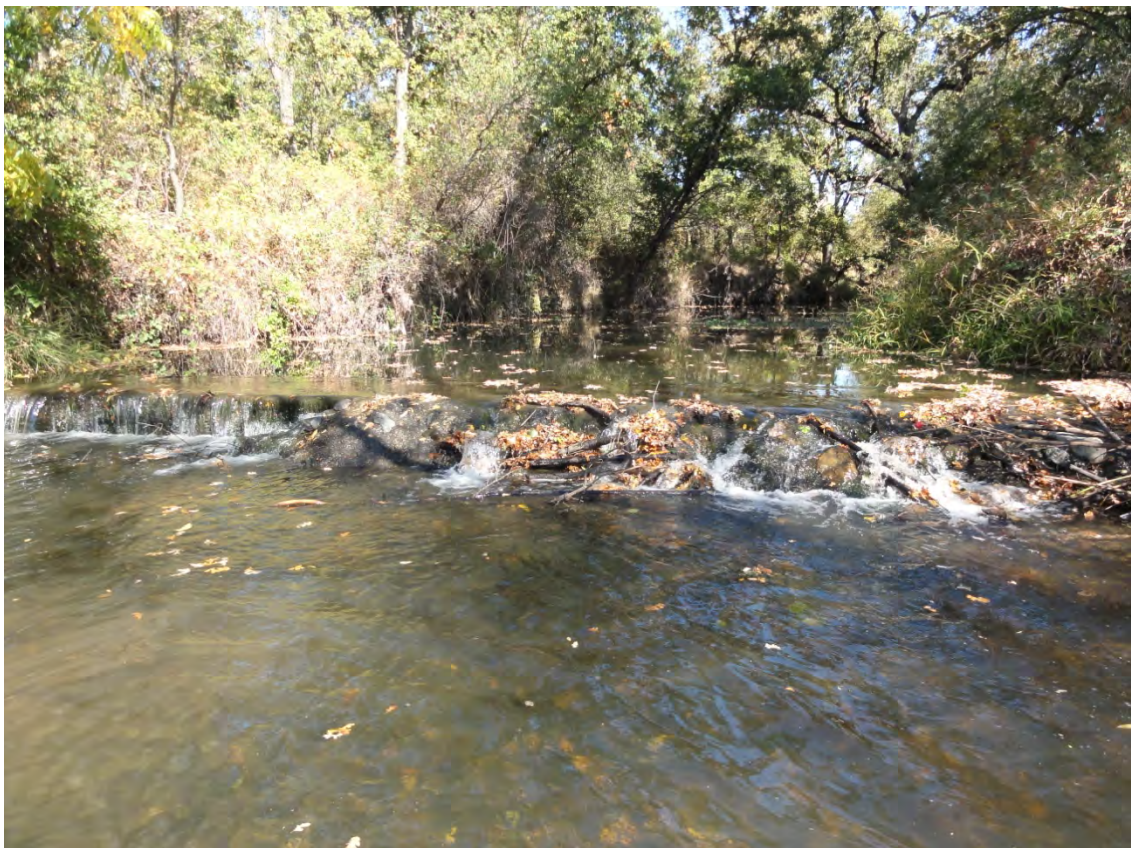
Figure 11

Notes: Cobble weir on Linda (top); concrete weir (potential sewer line crossing) south of Sierra Gardens Dr (bottom)

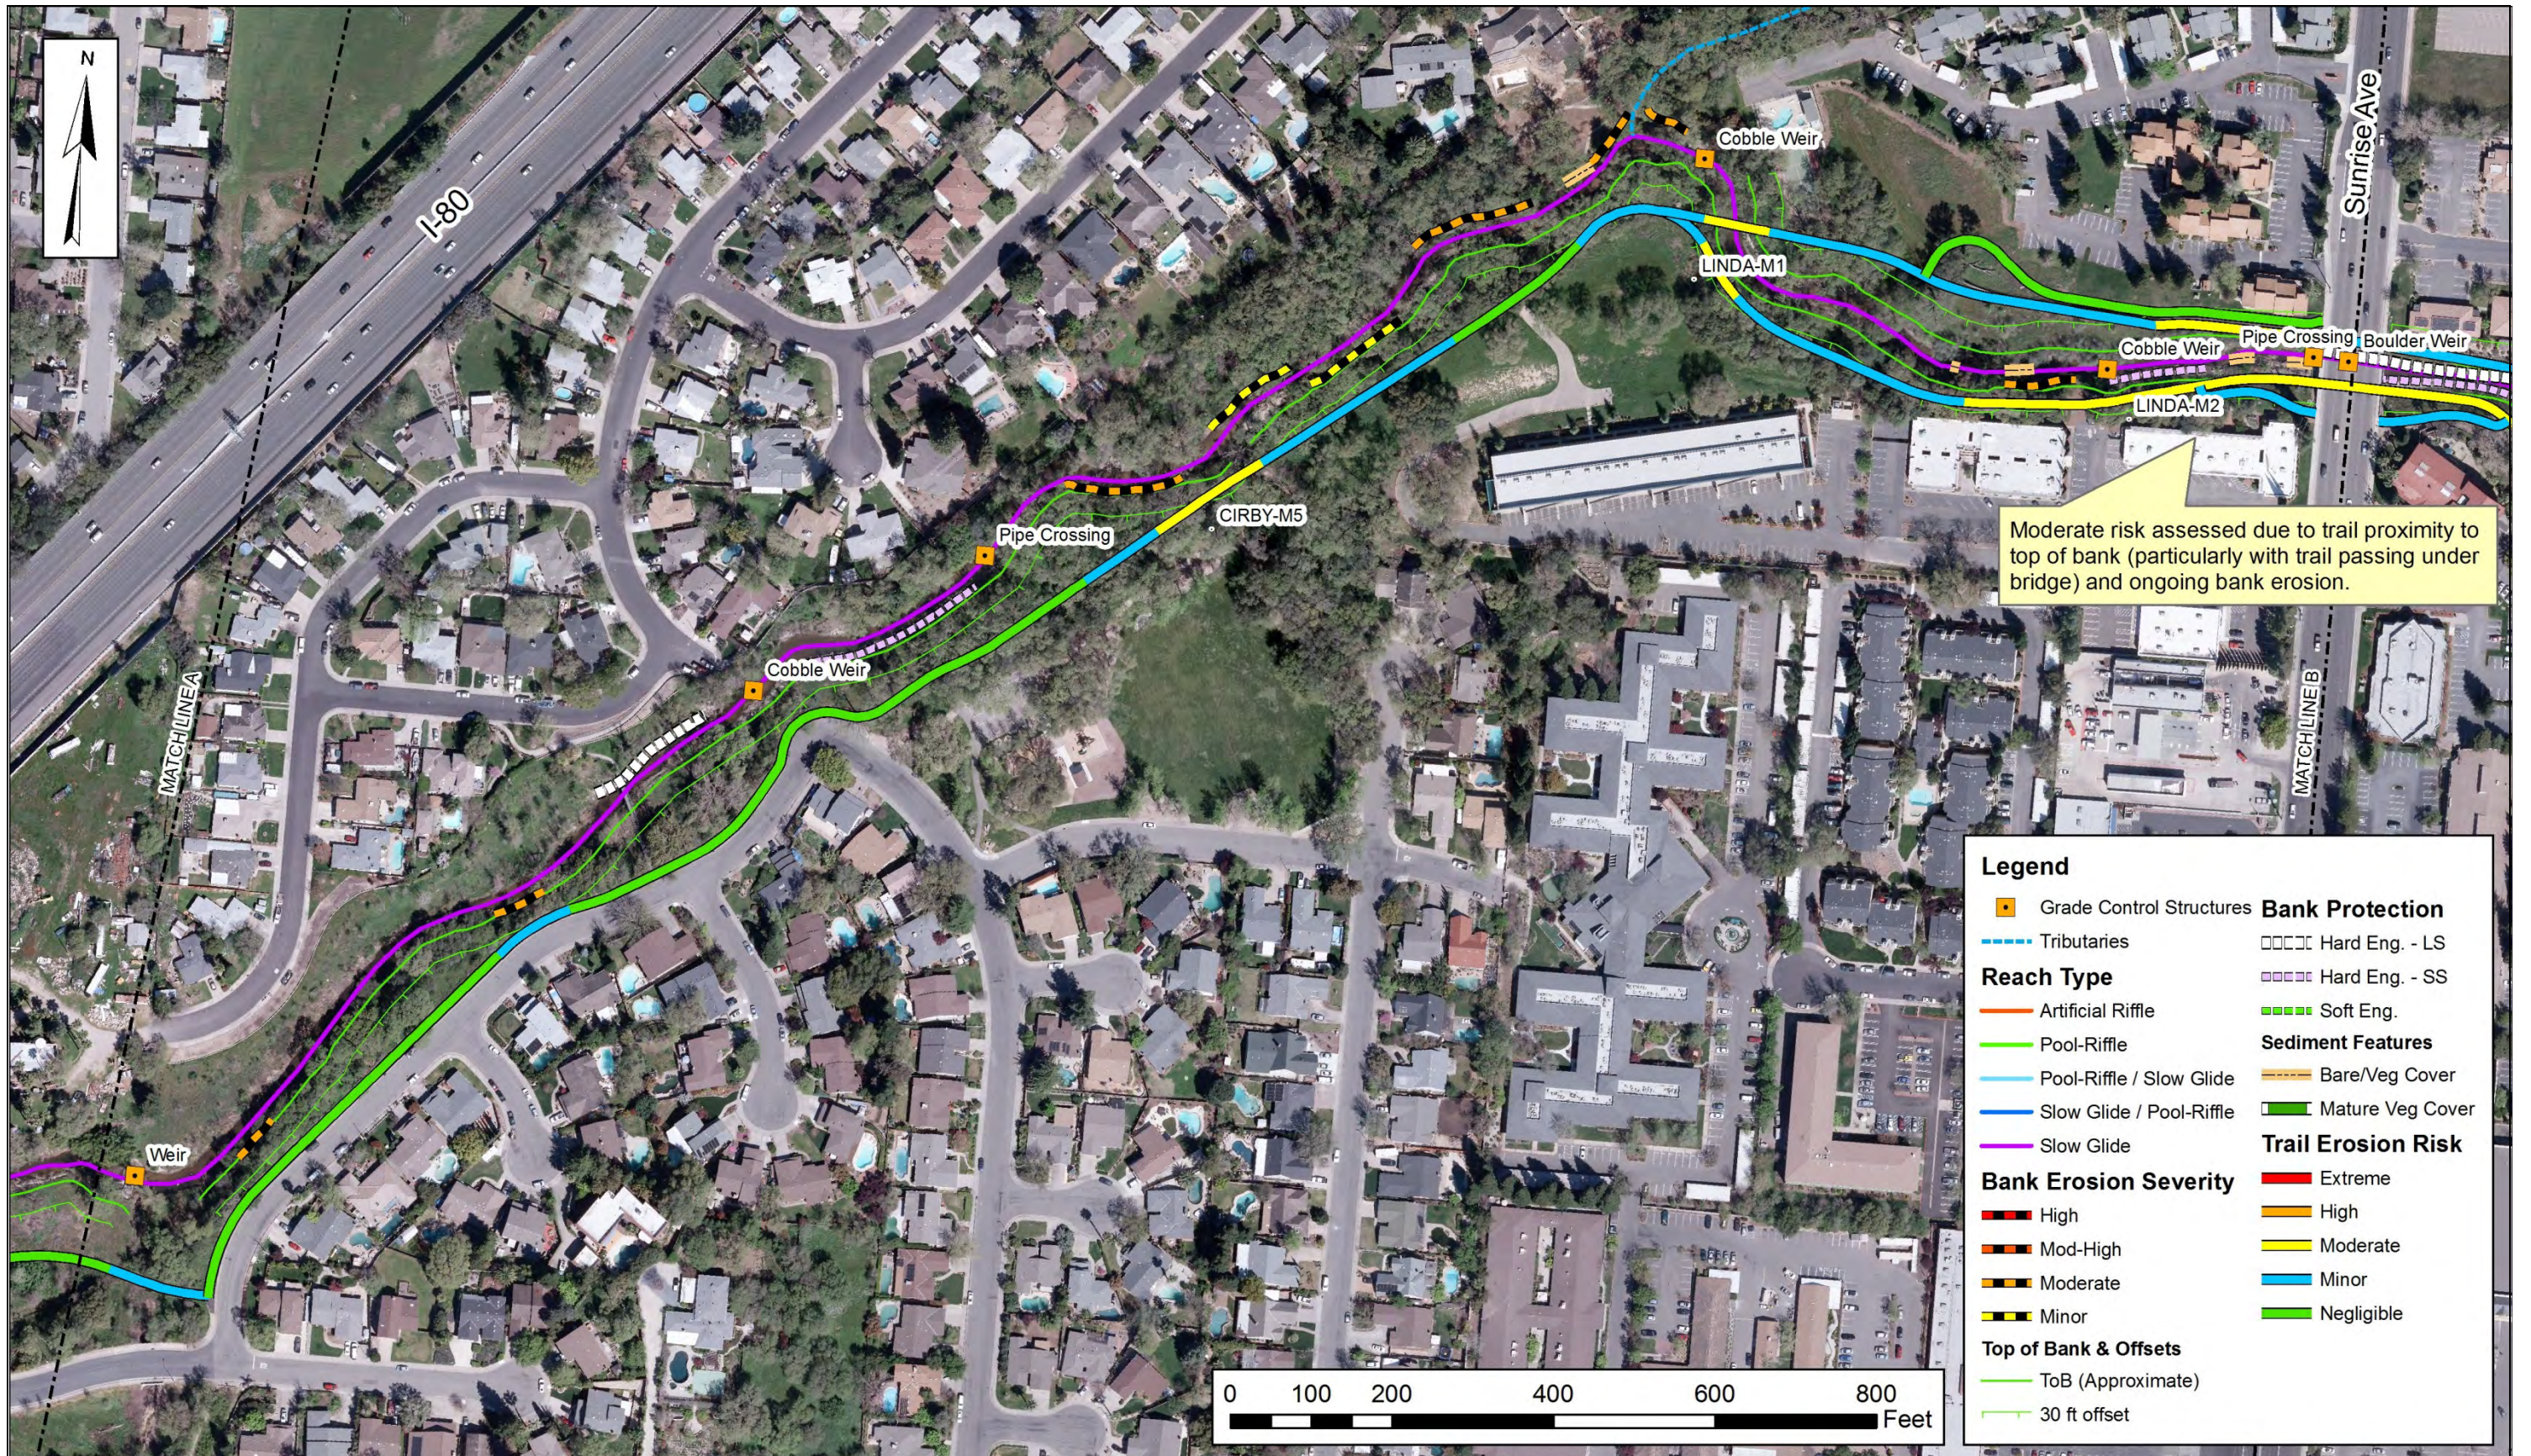
Moderate risk assessed due to trail proximity to top of bank (particularly with trail passing under bridge) and ongoing bank erosion.

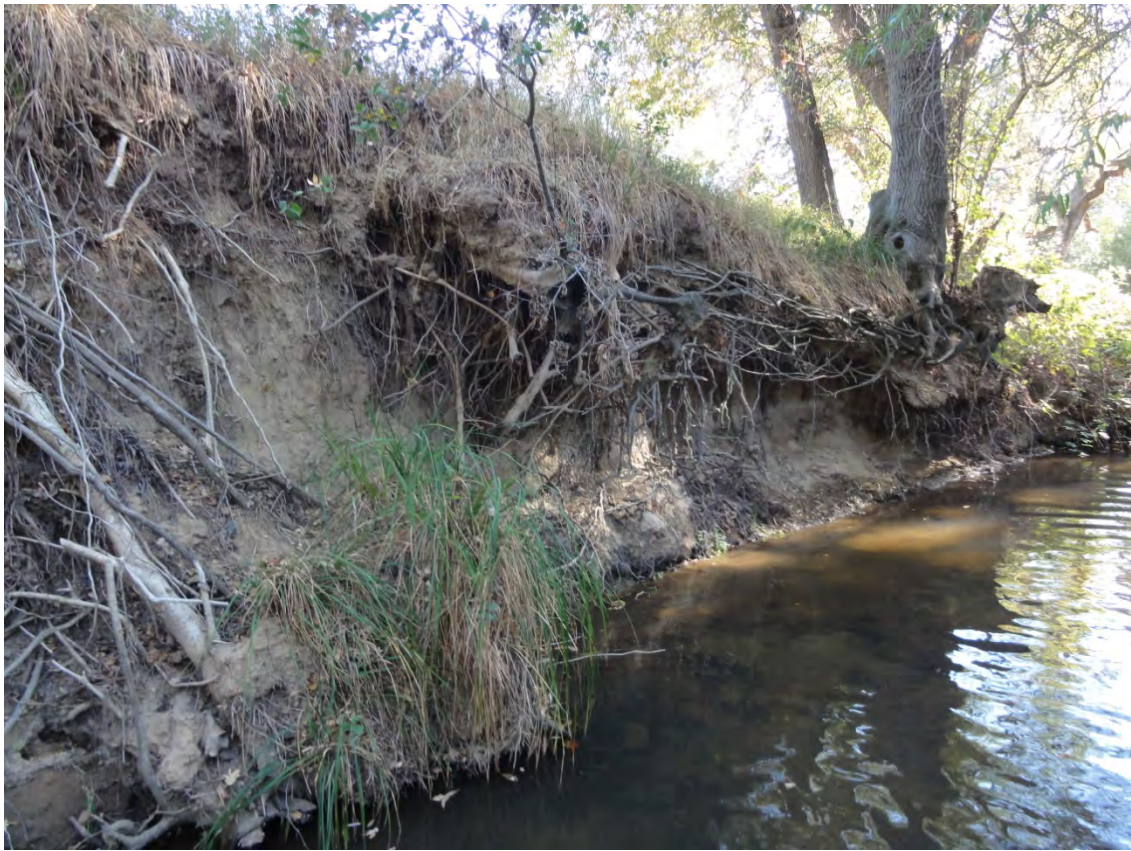
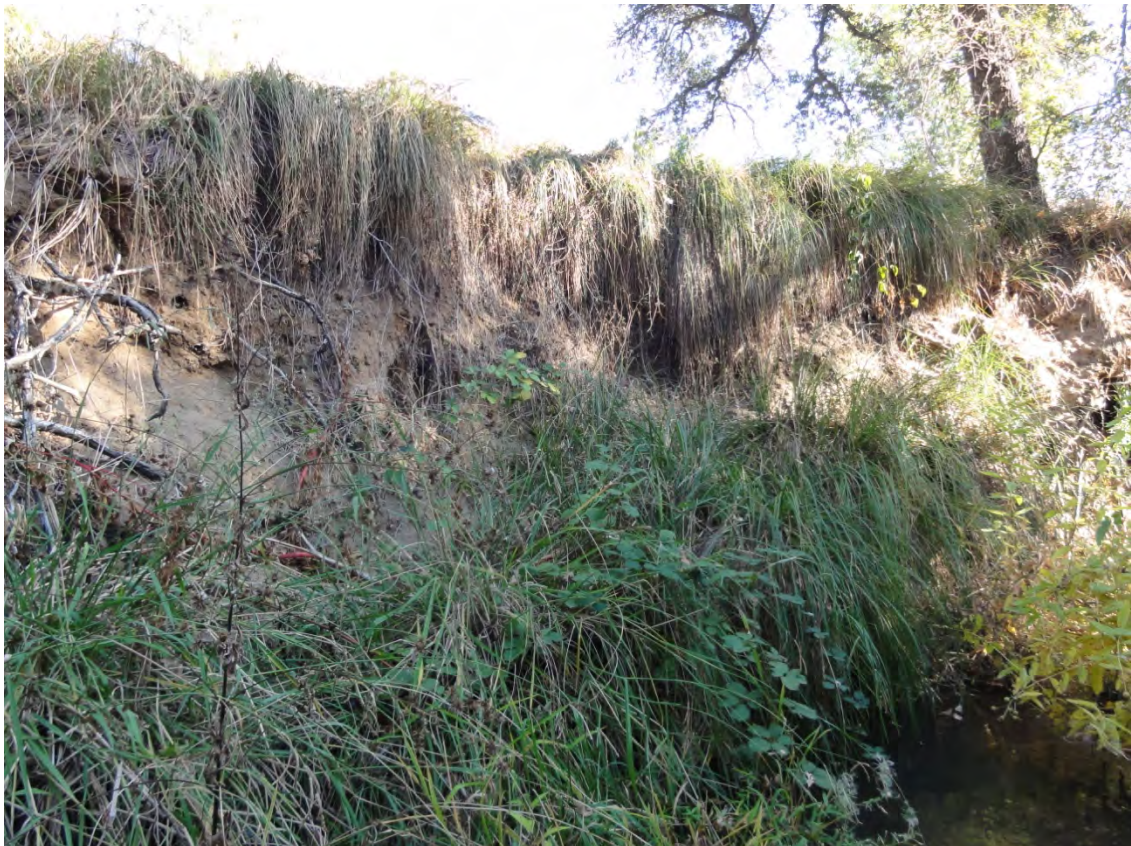
Figure 25

LINDA-H3 was given a high risk assessment due to the trail's proximity to the top of bank and ongoing severe erosion (see Figures 25 and 31). The suggested actions are the same as those specified in LINDA-H2 but the bank protection and channel modification measures would need to be somewhat tailored to the site-specific conditions at LINDA-H3.

Notes: Bank erosion at downstream end (top) and upstream end (bottom) of LINDA-H3

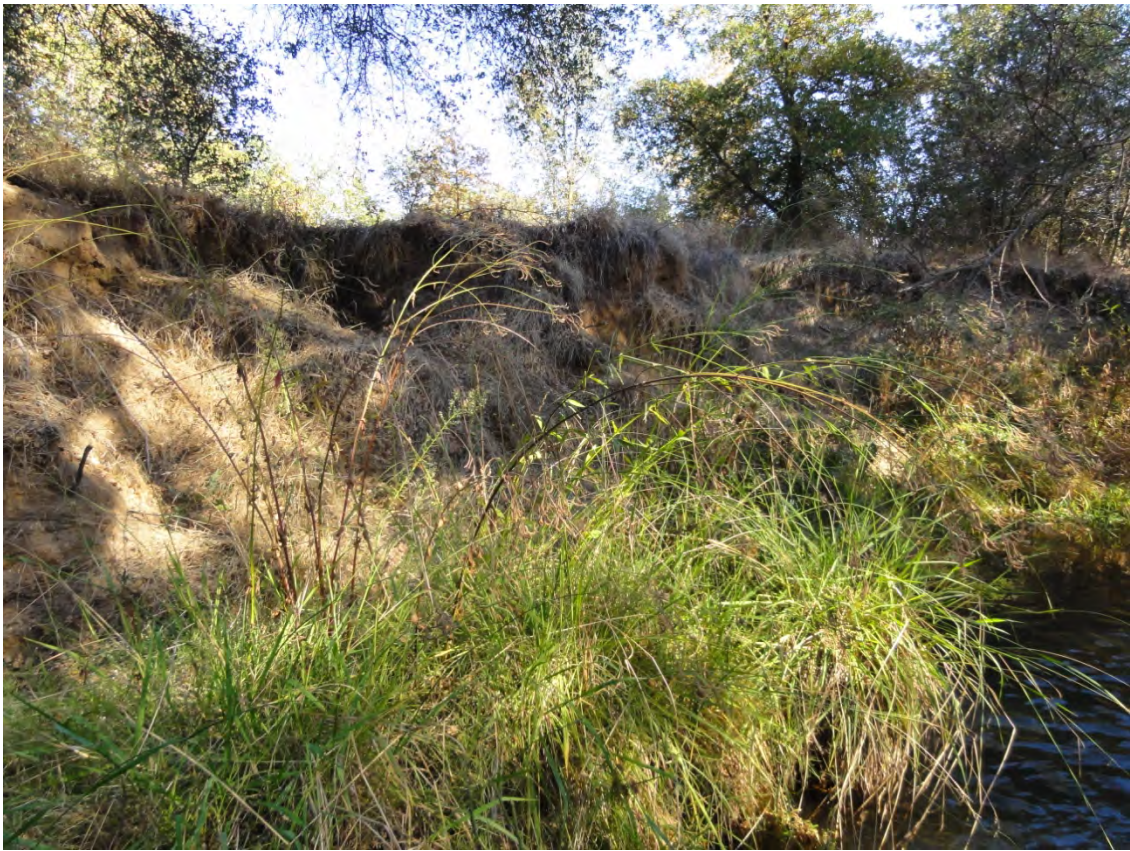
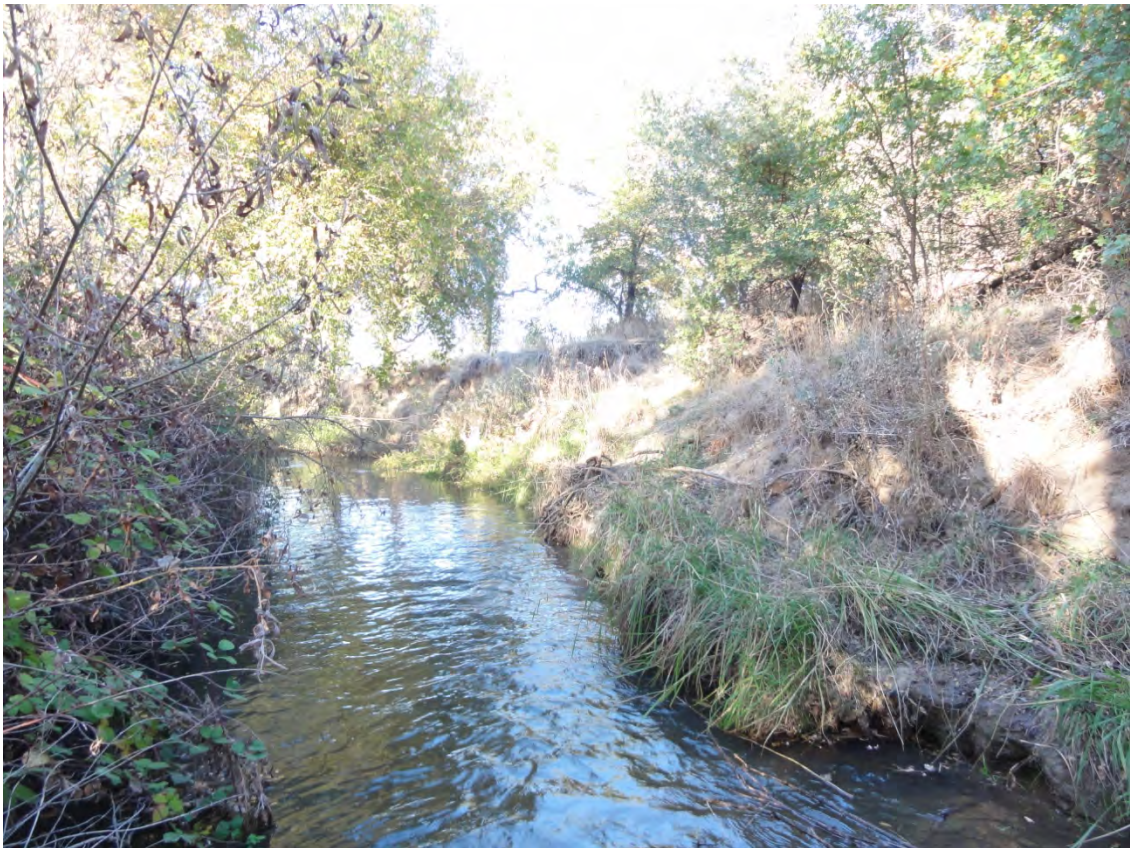
Figure 26

Notes: Bank erosion at
downstream end (top)
and continuing upstream
(bottom) along LINDA-H3
