#### RE: Arborist Report for Old Roseville Townhomes Project, City of Roseville, California

Figure 1, Vicinity Map Figure 2, Protected Tree Locations and Project Impacts

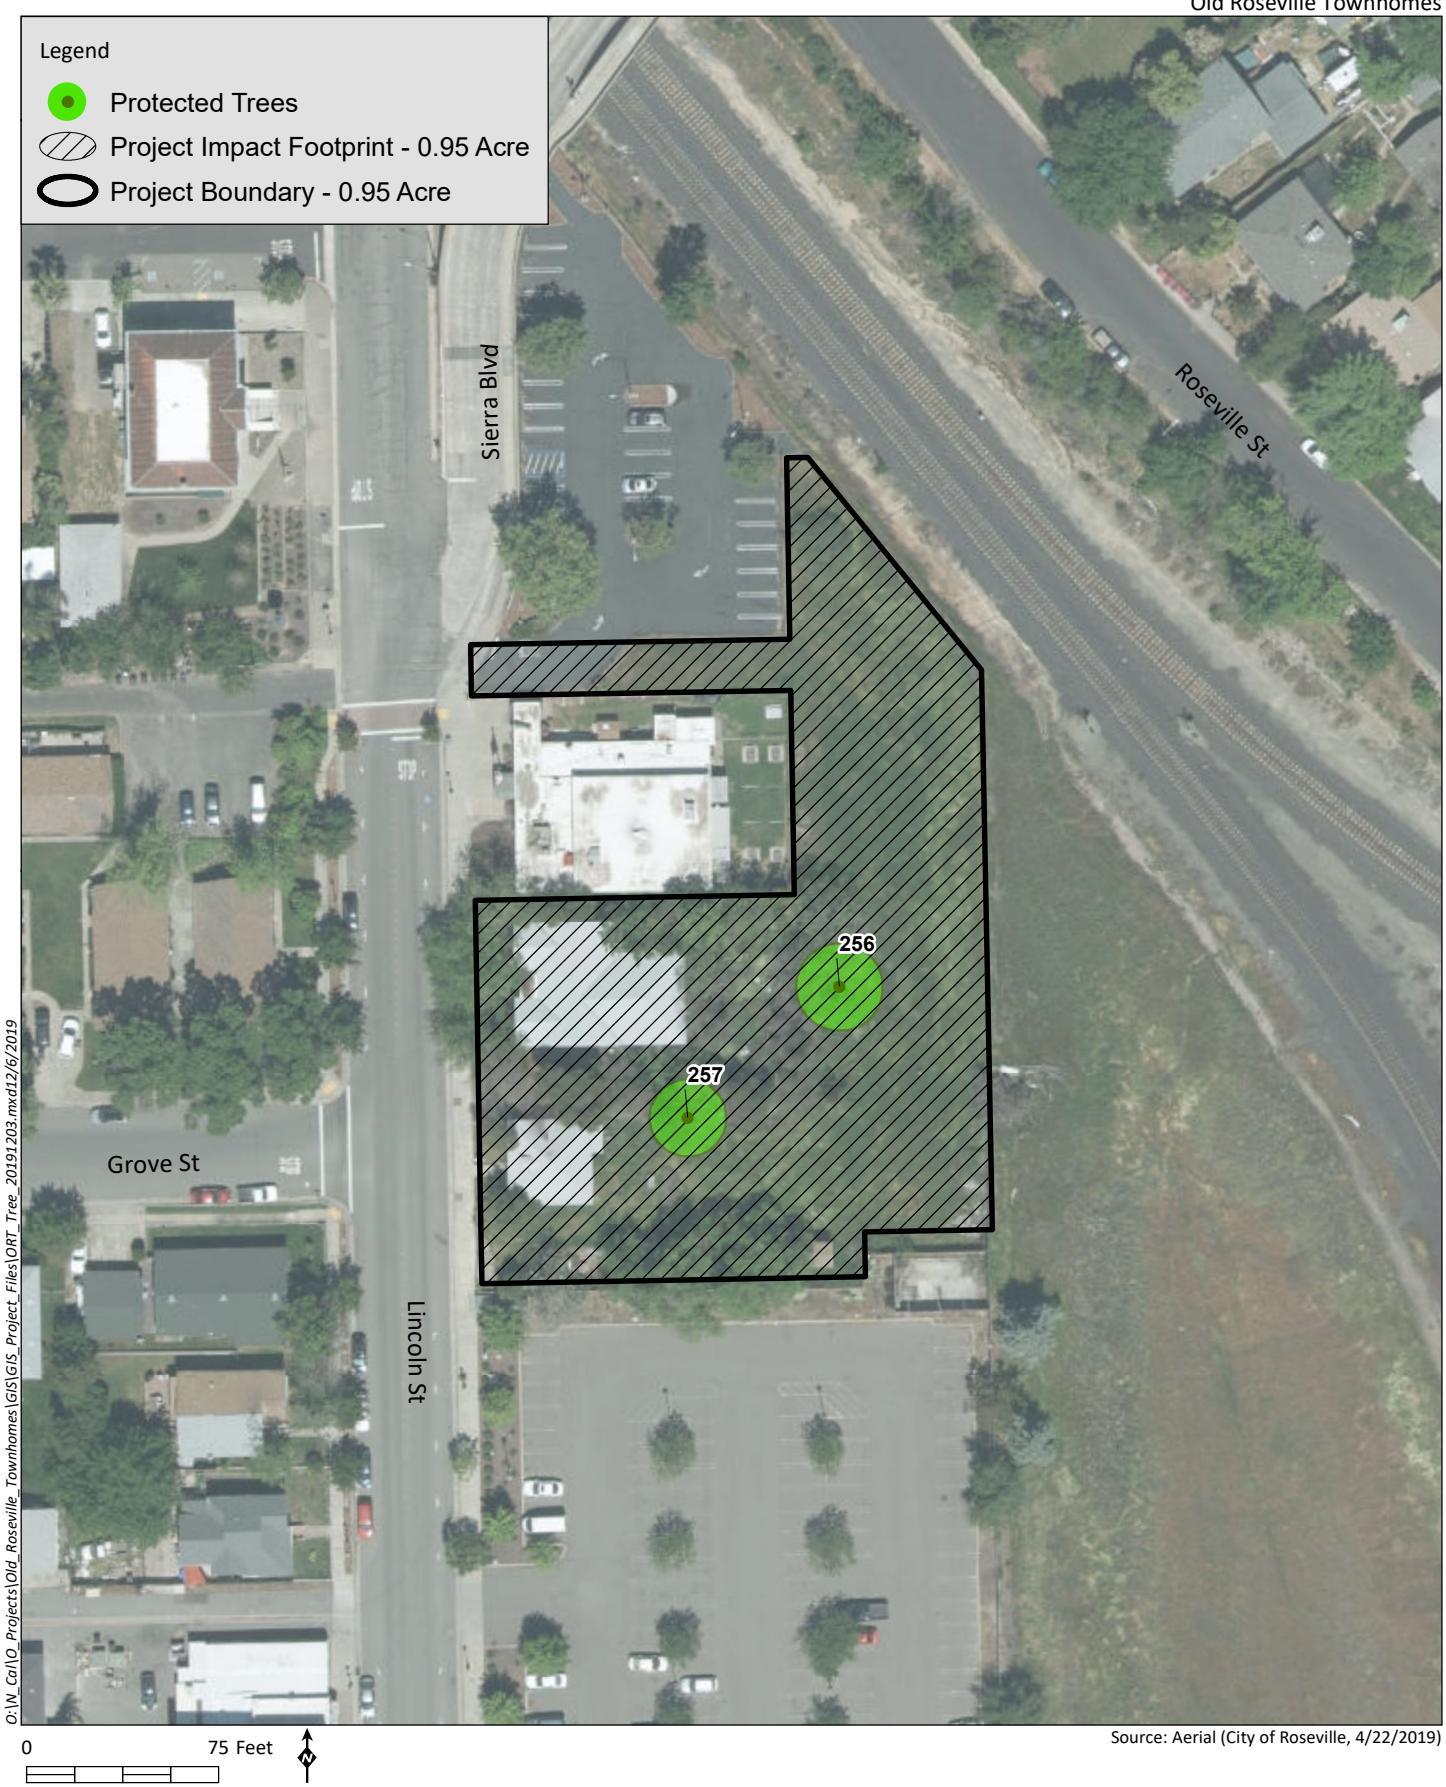
Figure 2

A total of two protected trees were surveyed within the project footprint. Both trees identified in the survey area were valley oak trees (*Quercus lobata*). Additional tree species identified, on the project site but not protected under the City Code, included Catalpa (*Catalpa speciosa*), London plane (*Platanus x acerifolia*), almond (*Prunus dulcis*), mulberry (*Morus alba*), juniper (*Juniperus sp.*), edible fig (*Ficus carica*), citrus (*Citrus sp.*), and privet (*Ligustrum sp.*). Detailed tree data for the two protected surveyed trees is included in Table 1. The approximate locations of the two protected trees and their driplines are shown on Figure 2.

Of the two protected oak trees within the survey area, one (#257) is in Fair-Good health and Fair structure, and the other (#256) is in Fair health and Poor-Fair structure (due to a heavy lean and an asymmetrical canopy weighted on one side). While failure of this structurally compromised tree does not appear imminent, problems can worsen over time, leading to failure. Although a crown cleaning and pruning to lighten overburdened limbs would reduce the risk of failure, there is no treatment that will correct these structural issues. If failure were to occur, then the tree may be uprooted and cause damage to targets; therefore, this tree is recommended for removal.

The Proposed Project will remove the two protected oak trees within the survey area (Figure 2). One tree (#256) is recommended for removal.

## **Protected Tree Locations and Project Impacts**

Since one of the two protected trees (#256) to be removed by the project is recommended for removal due to poor condition, no mitigation is anticipated for removal of that tree. Tree #257 requires mitigation on an inch-for-inch basis. This can be in the form of 15 (15-gallon) replacement trees, eight
