Dry Creek Greenway Trail Fluvial Audit

December 2014
Project Number: 13-1041

**DRY CREEK GREENWAY TRAIL FLUVIAL AUDIT
ROSEVILLE, CA
FINAL REPORT**

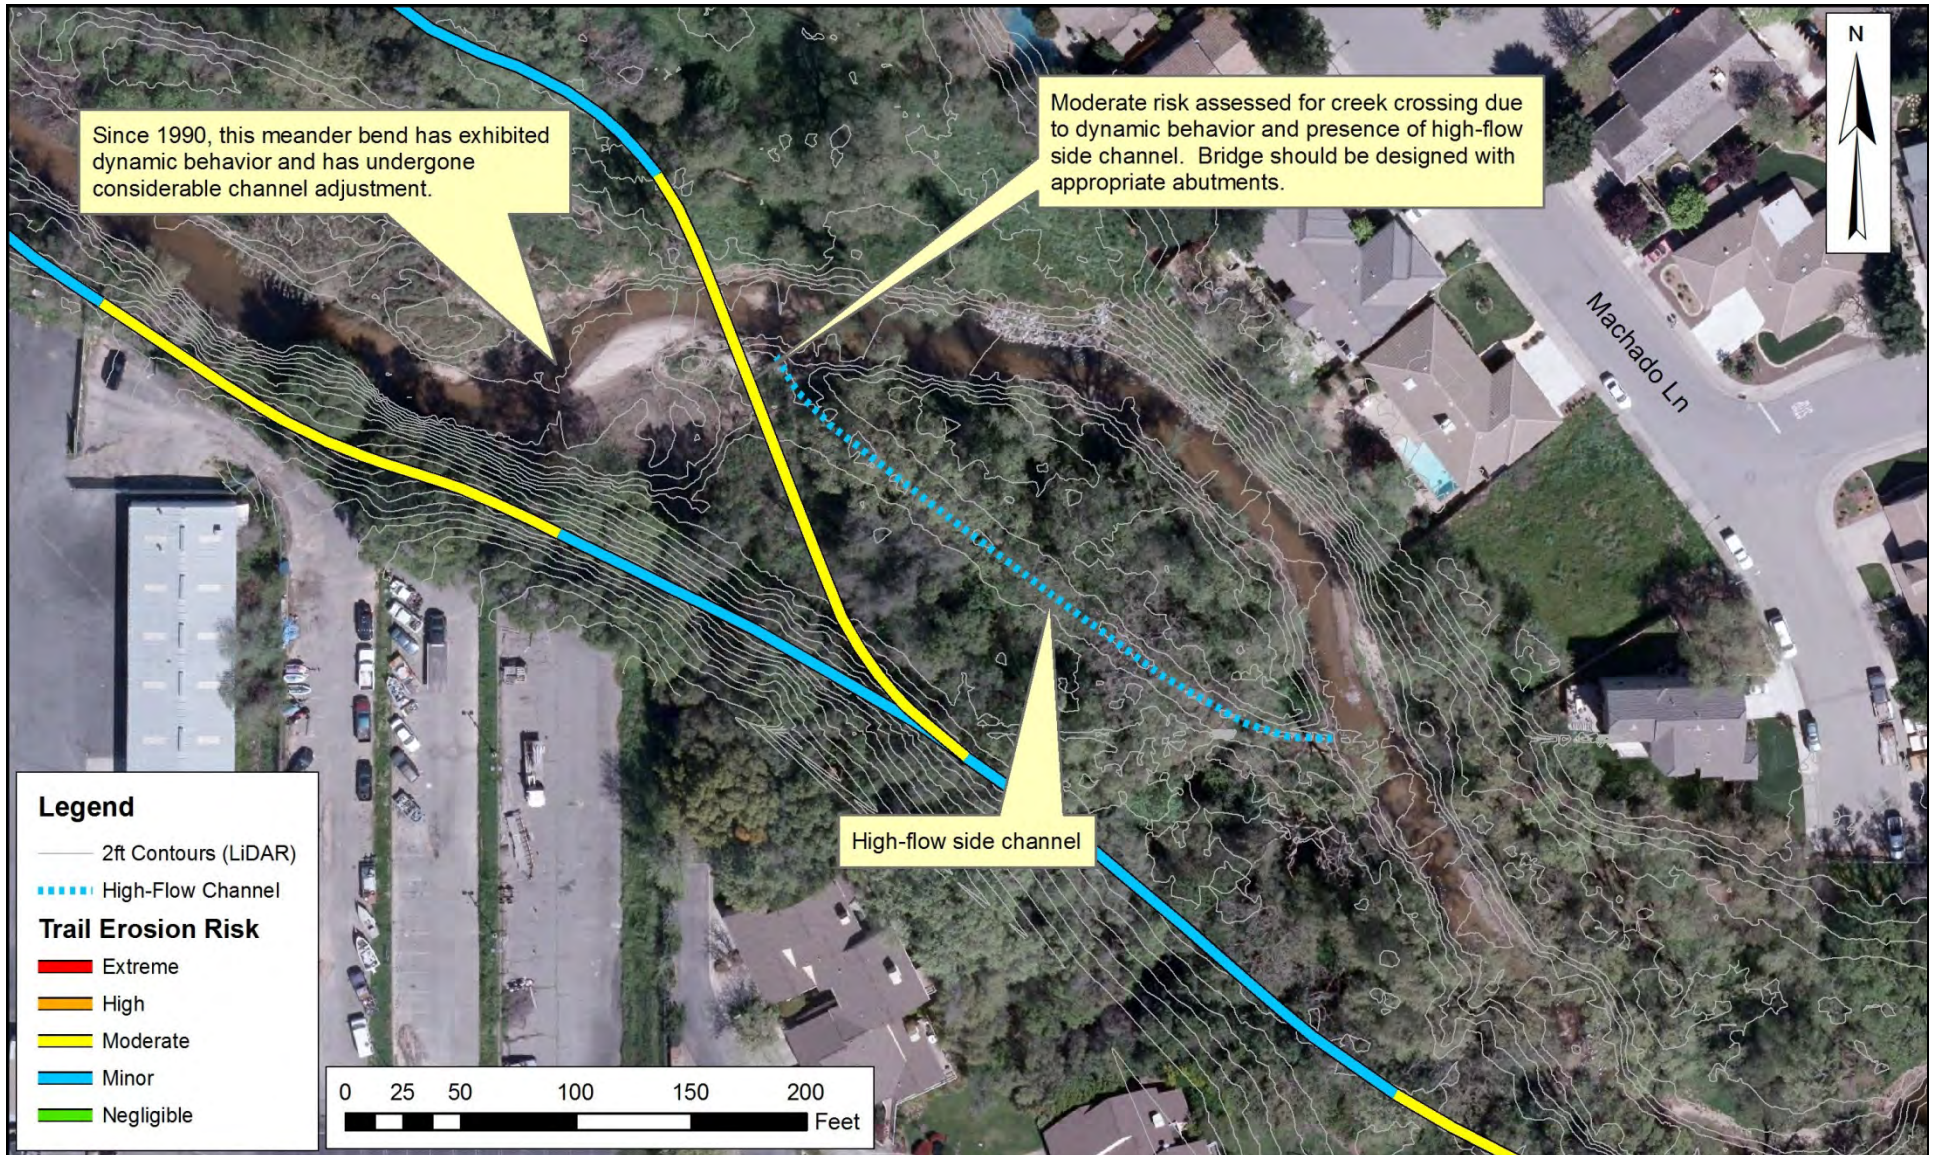
Figure 1

1. Roughly 400 feet upstream of the confluence of Cirby and Dry Creeks is a high-flow side channel on the southern side of Cirby Creek's main channel (see Figure 1). At the downstream end of the side channel, the main channel has exhibited considerable dynamic behavior and bank retreat since 1990. This dynamic behavior and the presence of the side channel should be considered in assessing trail location and the design of a stream crossing and any associated bridge abutments.

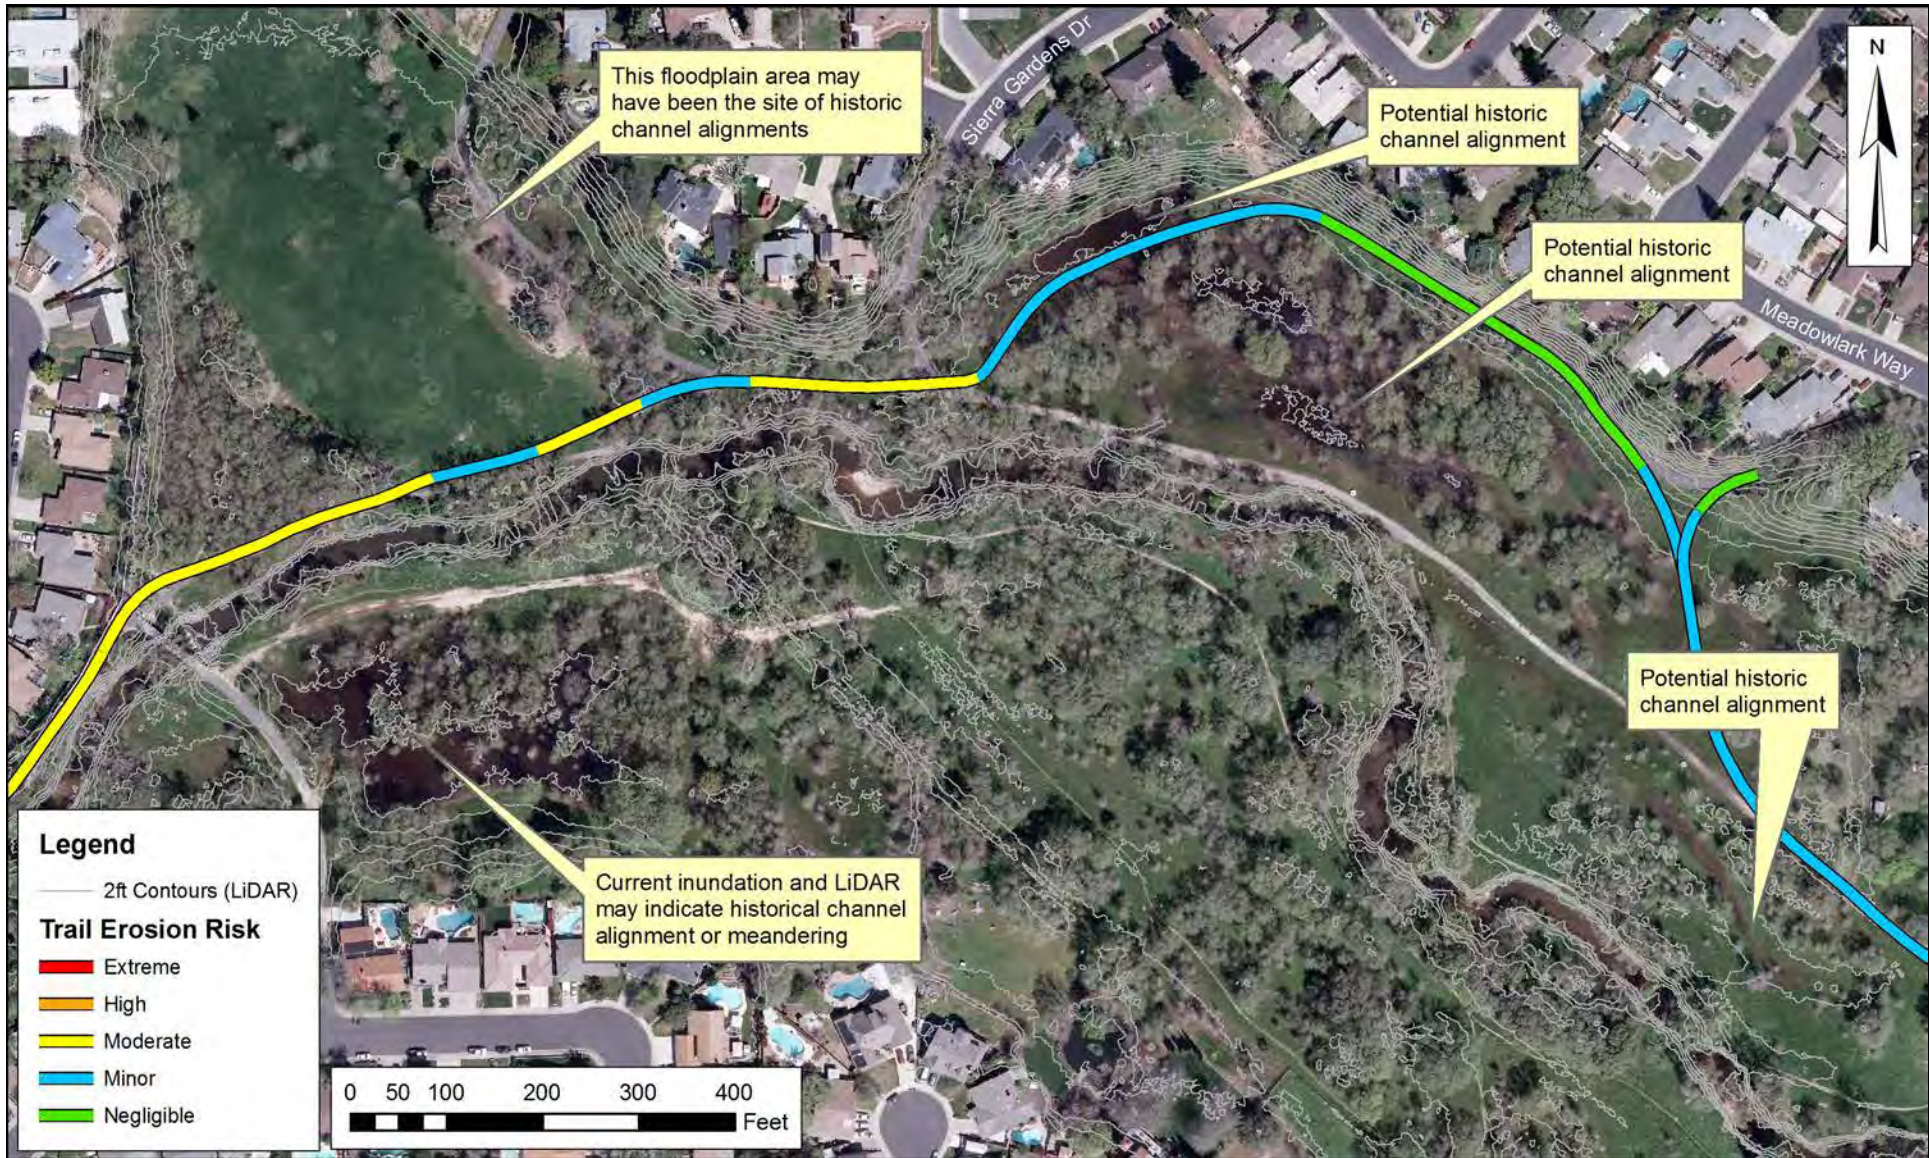
Figure 2

2. In the open space south of Sierra Gardens Drive and Meadowlark Way, the relatively wide floodplain area shows evidence of numerous historical channel alignments (see Figure 2). While historical aerials do not indicate dramatic shifts in channel alignment since 1990, it is important to note that this section of Linda Creek and its floodplain have demonstrated significant dynamic behavior over longer historical time frames.

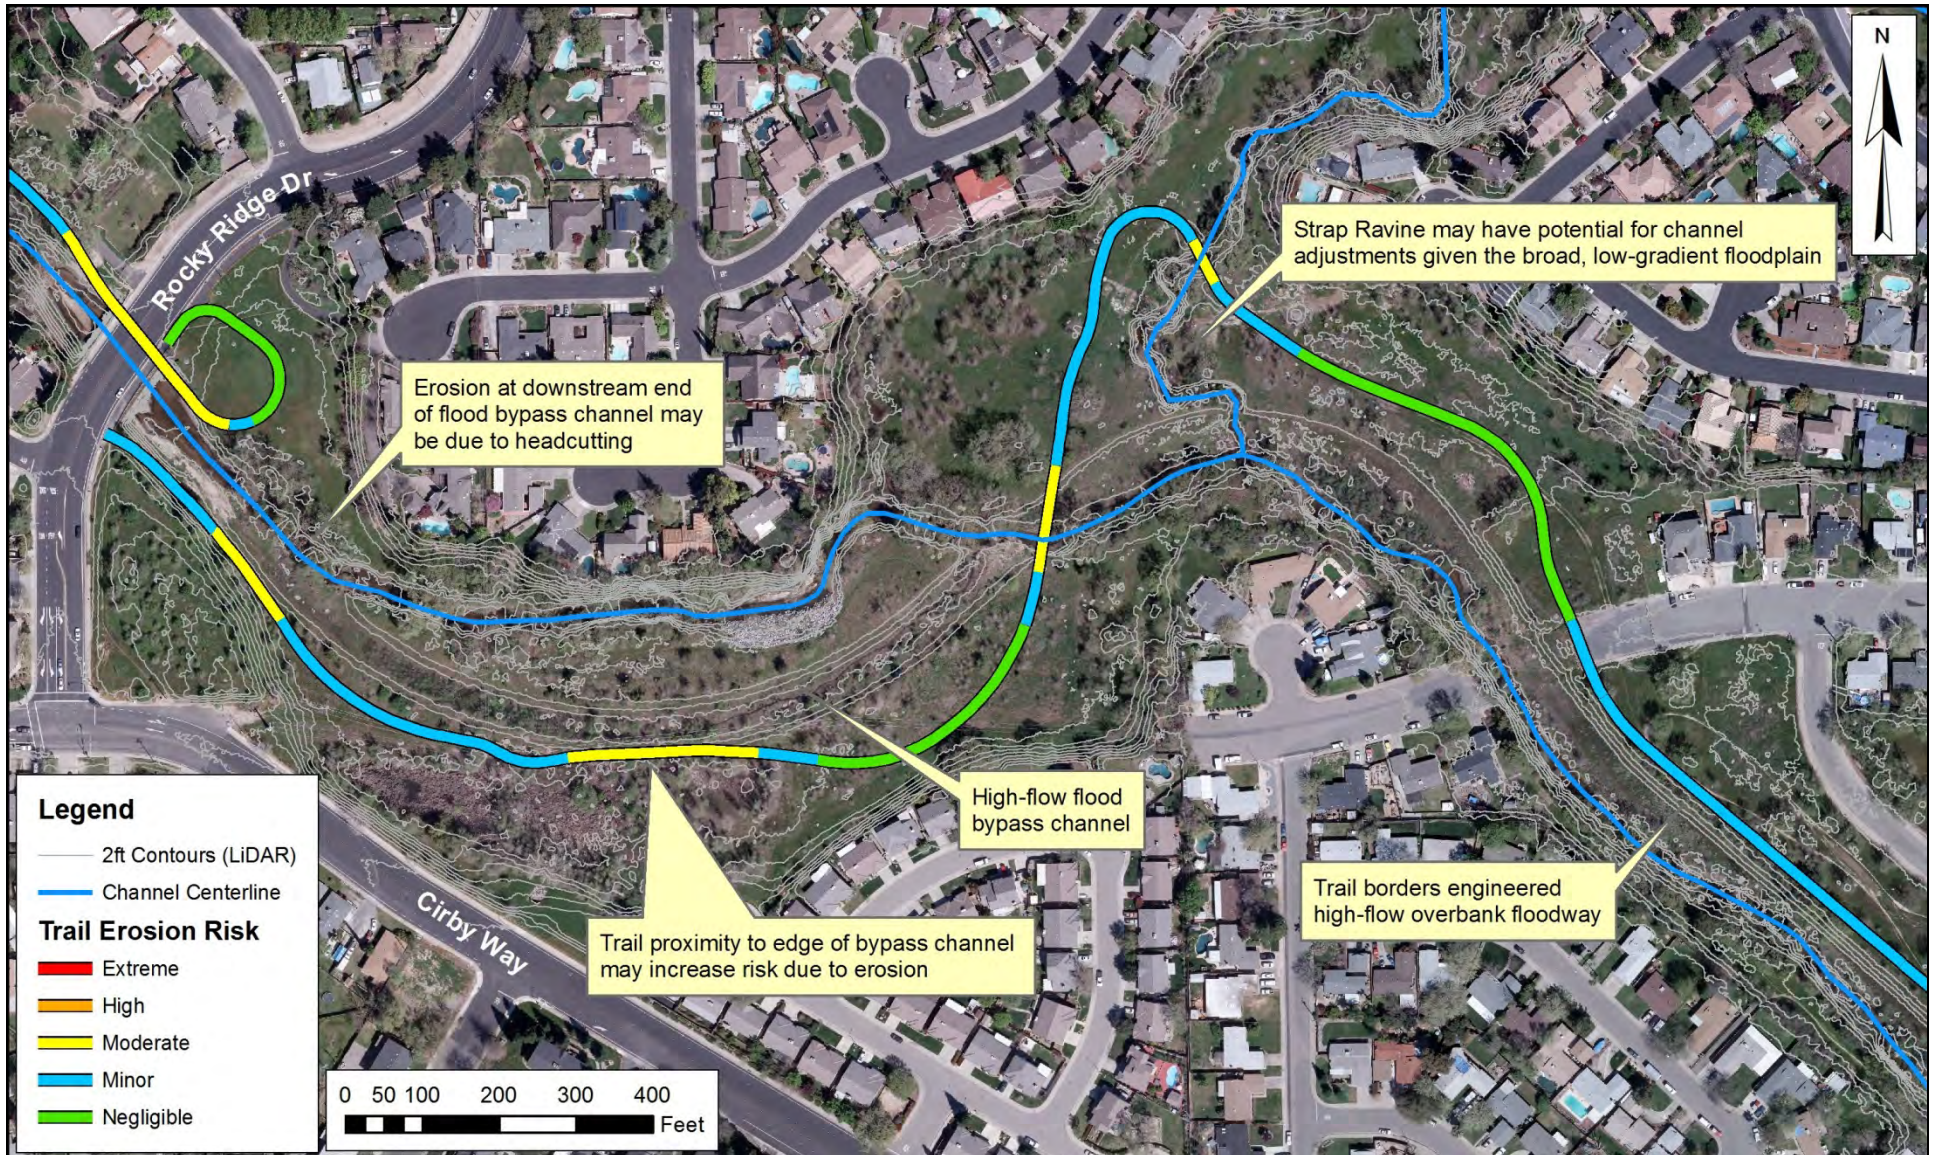
Figure 3

3. Between Rocky Ridge Drive and Champion Oaks Drive, a high-flow flood bypass channel is present in the Linda Creek floodplain (see Figure 3). This flood bypass channel interacts with the main channel in a number of locations and likely influences in-channel hydraulics and bank erosion. The proposed trail's proximity to the flood bypass channel may increase erosion risk to the path at several locations.

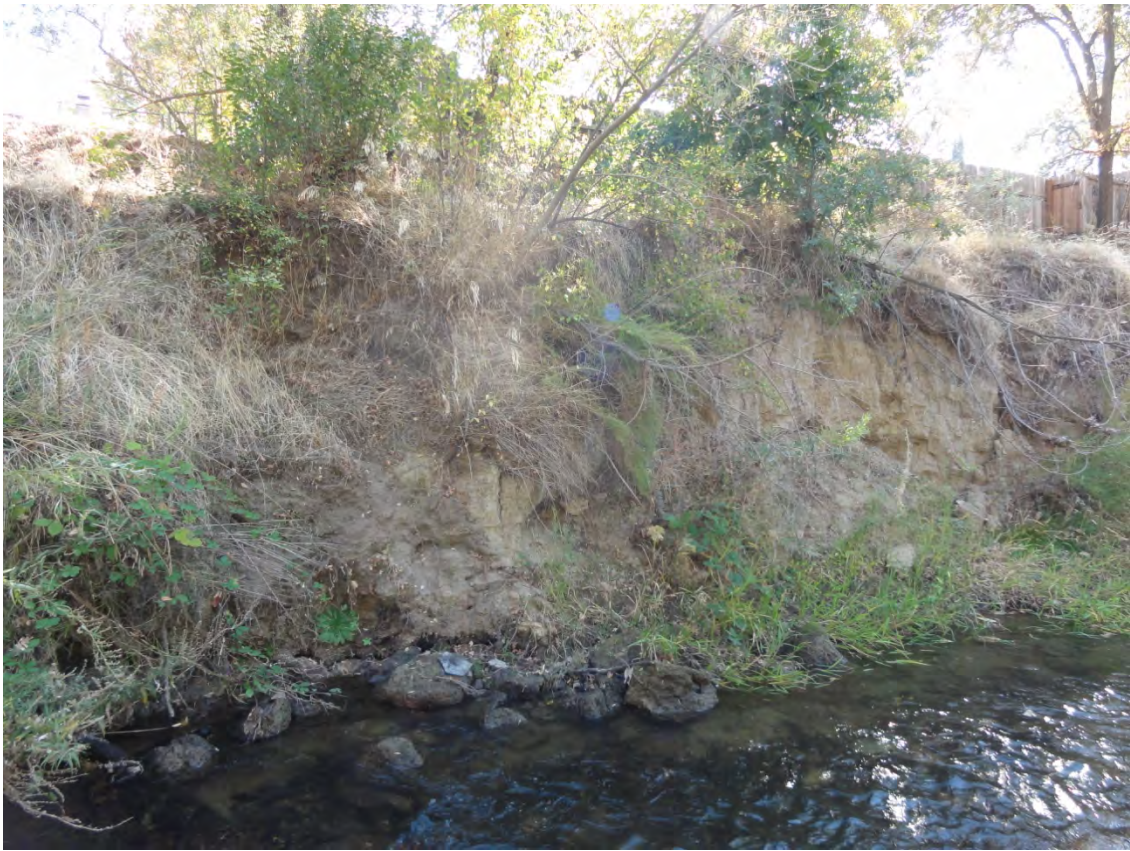
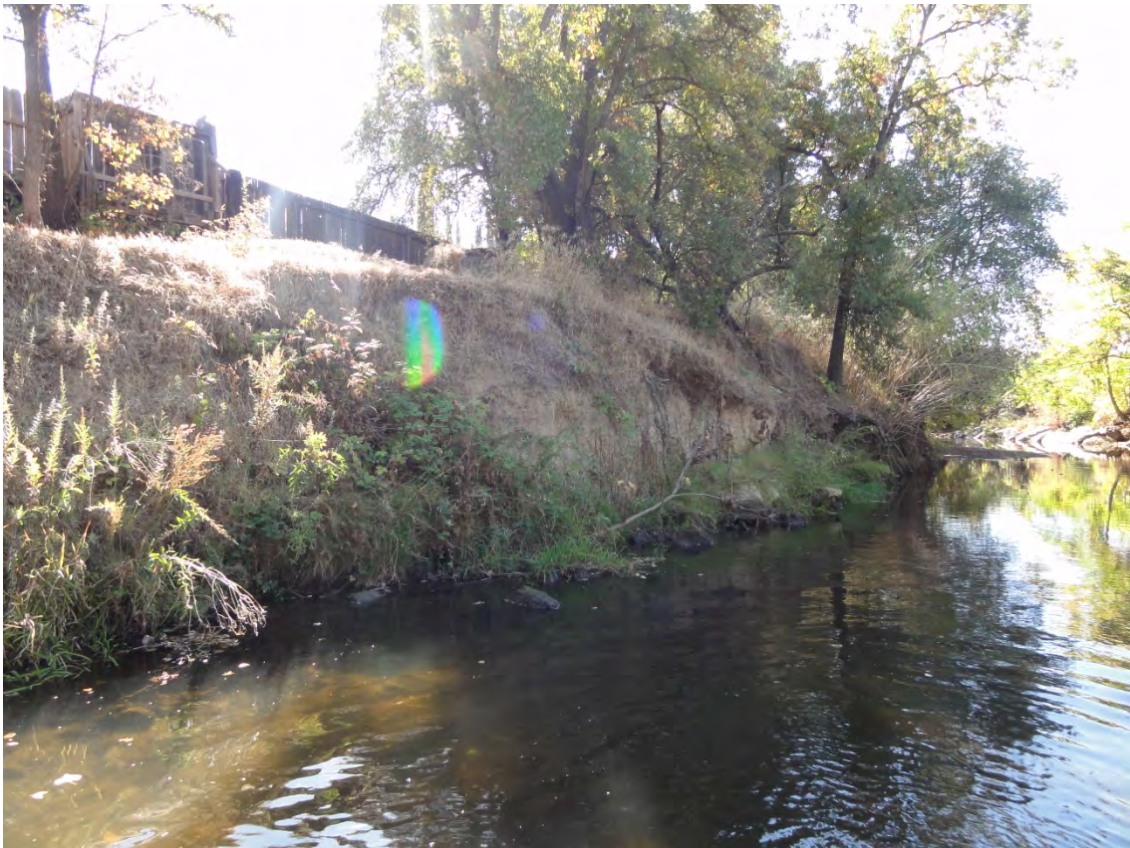
This section of trail along the left-bank of Dry Creek downstream of the Darling Way bridge runs parallel to a section of moderate severity bank erosion (see Figure 20 and 27). The proposed trail is less than 10 feet from the approximate location of the top of the eroding bank. The sections of trail immediately upstream and downstream of this area were assessed with moderate risk, despite their not being adjacent to an eroding bank. However, their proximity to the channel, the nearby bank erosion and the bank protection measures in the reach that were already implemented along the opposite bank informed a moderate risk assessment. Given the relatively narrow space available between the top of bank and the private property fence line, the following actions are suggested in order of priority:

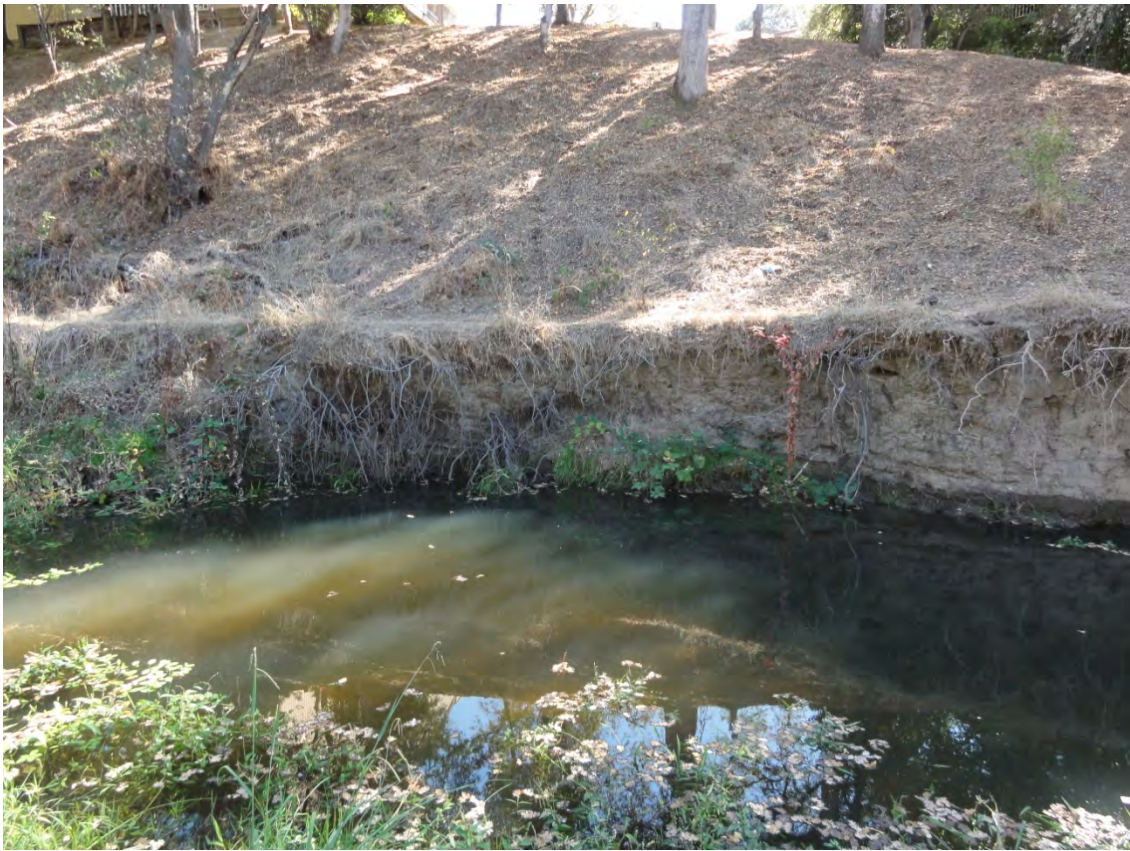
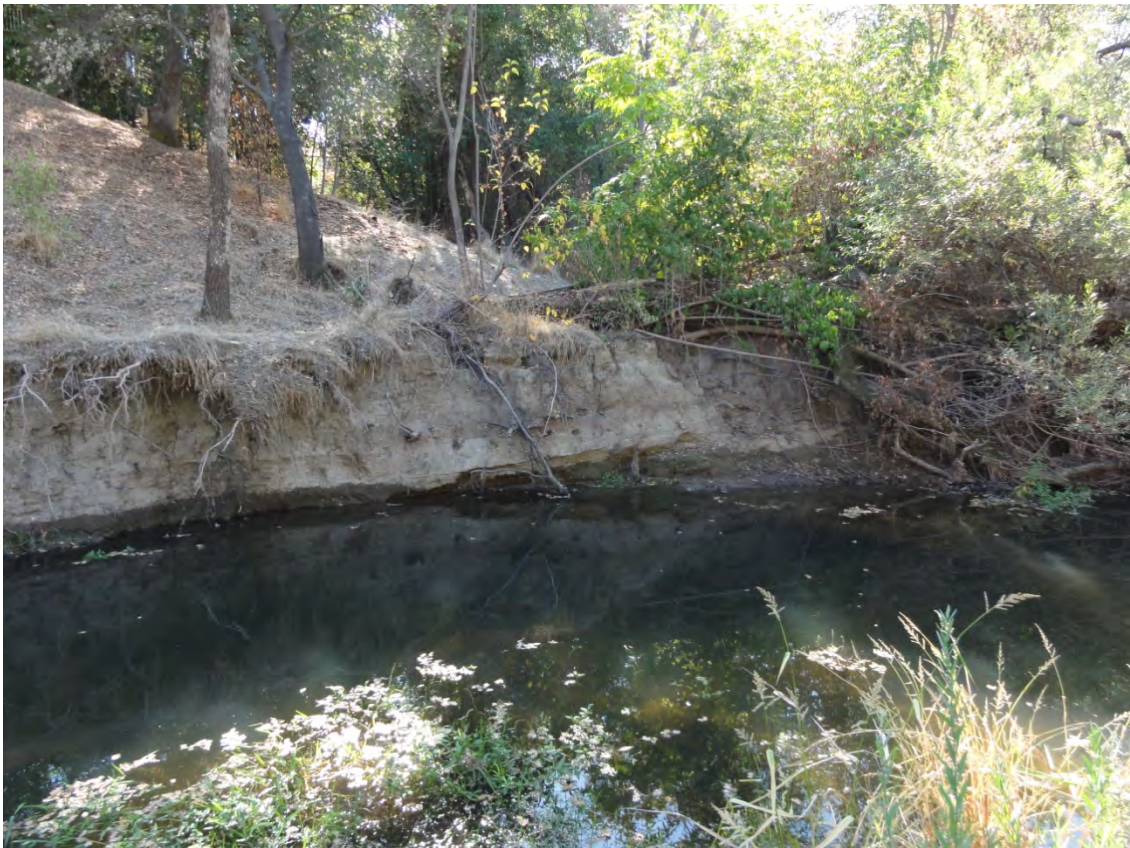
Figure 22

The proposed trail between I-80 and the confluence of Dry and Cirby Creeks has a segment of extreme and high erosion risk near Cirby Hills Drive and Machado Lane (see Figures 22 and 28). This section of trail along the southern side of the channel is the most concerning section of the proposed path along the entire length of the fluvial audit. The ongoing severe erosion and the limited space between the top of bank and the toe of the hill slope will likely jeopardize the integrity of the trail. The following actions are suggested in order of priority:

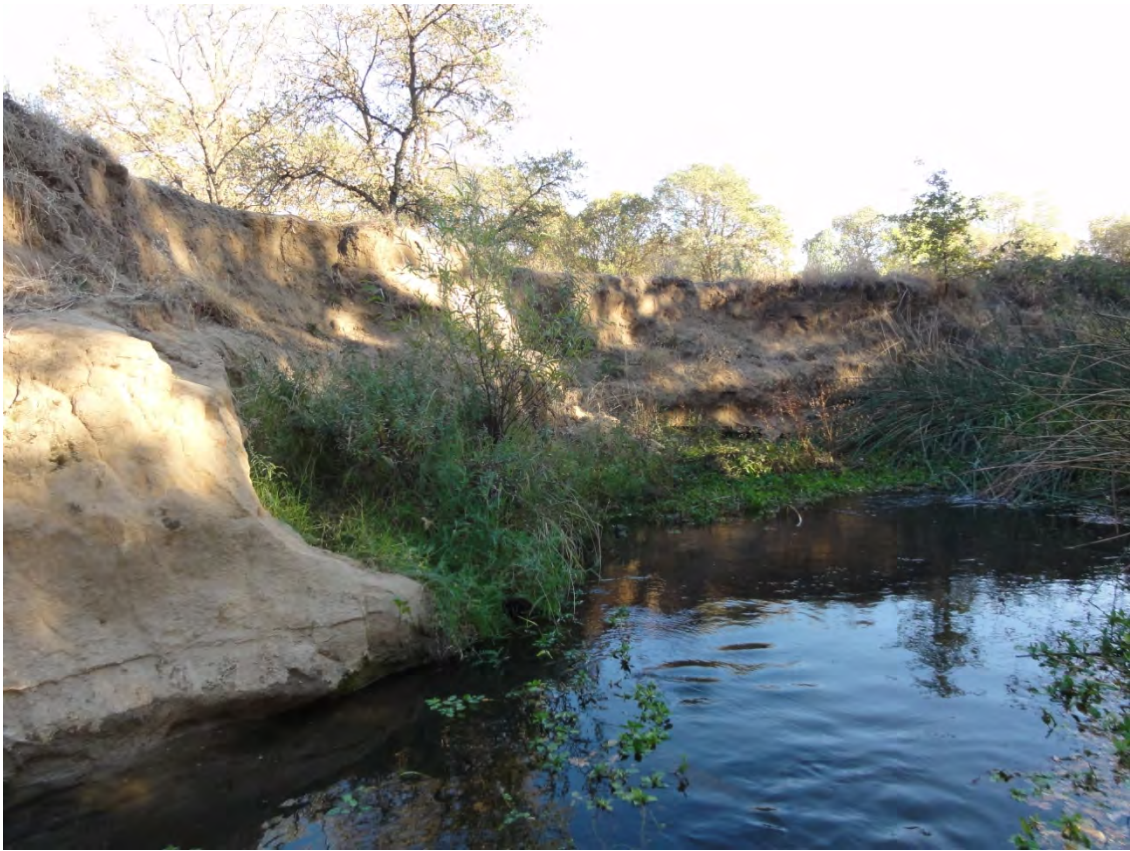
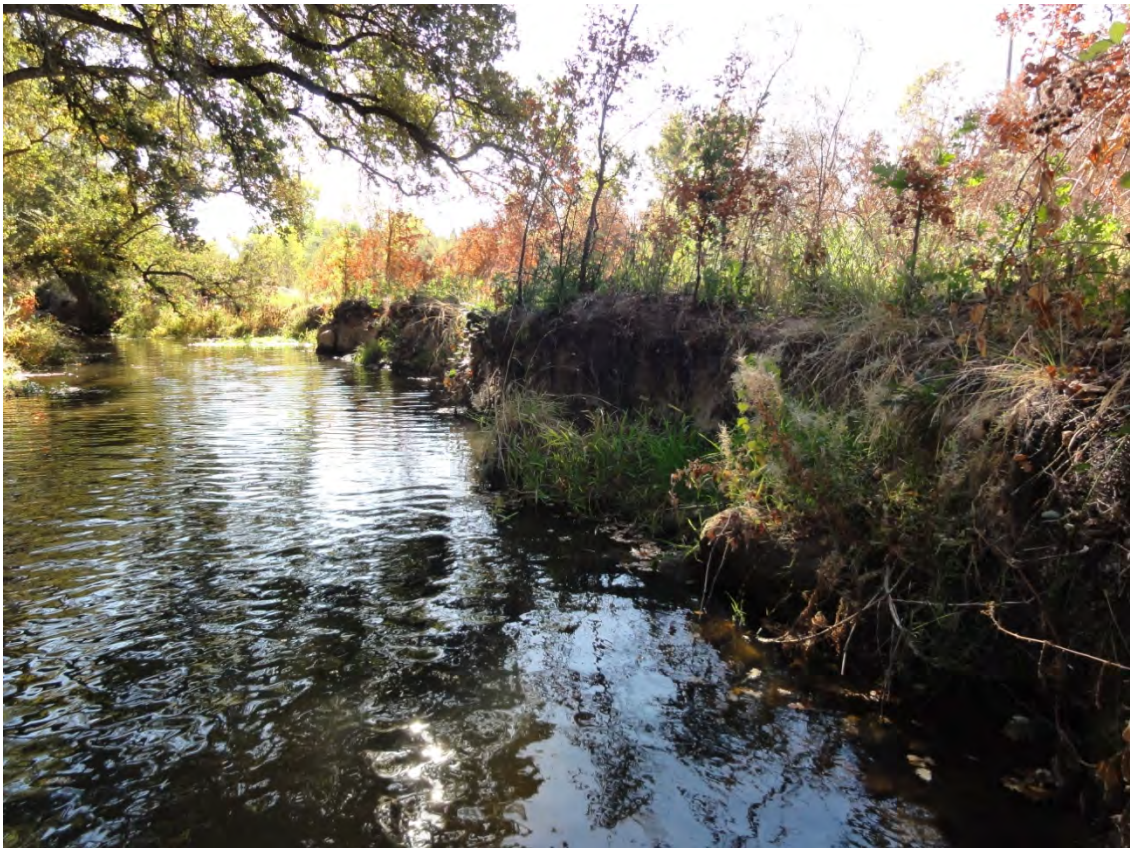
Figure 23

LINDA-H1 is the furthest downstream segment of trail along Linda Creek with a high risk classification. The trail is located adjacent to a lengthy section of bank erosion (see Figures 23 and 30) and is positioned on the outside of a relatively large radius meander bend. The extent of bank erosion may be enhanced somewhat by a pipe crossing the channel with an angled alignment rather than one that is perpendicular to flow. The angled alignment may be directing erosive energy towards this outside bank, contributing to bank erosion at the site. Given the close proximity of the proposed trail alignment to the top of bank, the following actions are suggested in order of priority:

1. To the extent possible, set the trail alignment further back from the channel in the direction of the floodwall.
2. Address bank erosion through one of the following sets of actions:
 - a. Applying standard bank protection measures along the outside, eroding bank to protect against further erosion.
 - b. Applying the suite of options indicated in Figure 32:
